**RESEARCH ON ADVANCED NONDESTRUCTIVE  
EVALUATION (NDE) METHODS FOR AEROSPACE STRUCTURES**

**UNIVERSITY OF DAYTON RESEARCH INSTITUTE**

**REPORT DATE: October 1998**

**FINAL REPORT FOR 9 SEP 94 THROUGH 30 SEP 98**

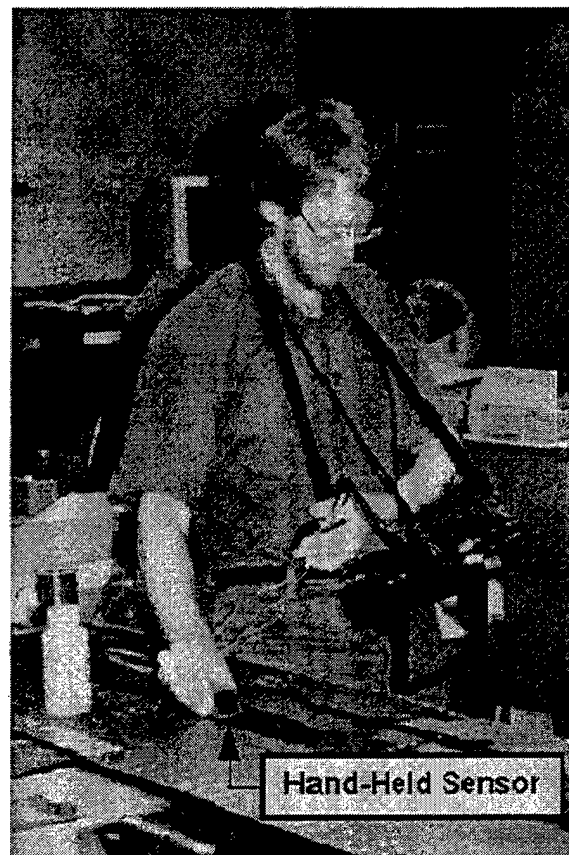
**FIGURE 4.1-8**  
**Laboratory Application of Transducer (hand-held sensor).**

In either mode, a portion of the incident acoustic pulse is specularly reflected from the near side of the hole; this signal is used as a time reference to judge the arrival time of the two possible situations for the creep wave. For an uncracked hole, the creep wave travels circumferentially around the hole and leaks back to the receiver (pitch-catch mode) at a time determined by the diameter of the hole. If the creeping wave encounters a crack emanating radially from the weep hole, a portion is reflected back toward the transmitting transducer and is detected in the pulse-echo mode. These conditions are illustrated in Figures 4.1-1 through 4.1-6, obtained from actual condemned C-141 wing panels. An optical photograph of a typical weep hole is shown in Figure 4.1-7, and the transducer is shown in use in Figure 4.1-8.

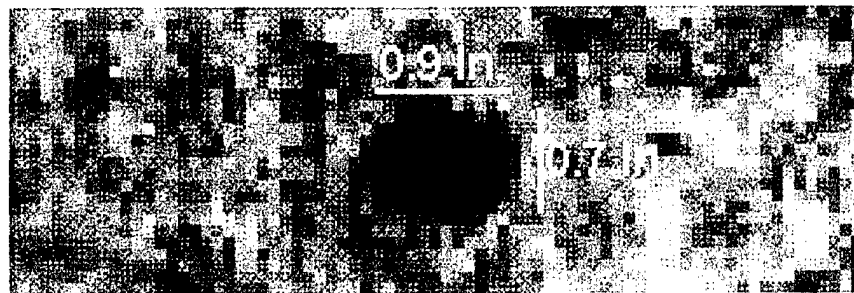
FIGURE 5  
Pulse-Echo Depth Images Showing Near-Surface Damage -- (a) Interrogation from the Front Surface and (b) Interrogation from the Back Surface

Comparison of the images in Figures 2 and 3 with the images in Figures 4 and 5 reveals that the resonance technique, when applied with the transducer in contact with the impact-damaged surface, provides smaller estimates of the impact-damage dimensions than does the pulse-echo technique. The reason for this difference in dimensional estimates between the two techniques is not known. The resonance technique also does not provide any layer-by-layer delamination-damage depth information, whereas some layer-by-layer delamination-damage depth information is provided by the pulse-echo technique (depth C-scan images only).
